Automatic Defect Recognition in MPI - Inland Steel Research Project

INLAND STEEL VISION RESEARCH PROJECT

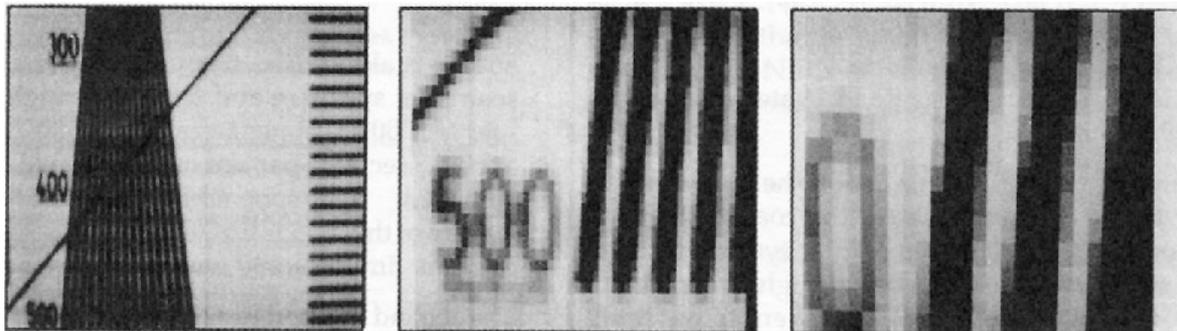
To illustrate the typical performance for a TDI System, an image was captured by a frame grabber and displayed on a monitor. This image is shown below and is the actual size of the document scanned. It should be noted that the zero in "500" is 39.4 thou (1mm) wide. Scanned at a speed of 240ft/min, the "500" is shown in the centre image below. The width of the line above the "500" is 1 pixel. The resolution of the camera is so fine that the output appears as a staircase pattern. The line width of the zero corresponds to a single photo element on the image sensor.

The uniformity of the image shows that the synchronisation that has been achieved is accurate to less than 1 pixel. For the camera used, 96 stages of 13um indicate a no vibration interval of 51.2 thou (1.3mm), which can be achieved relatively easily.

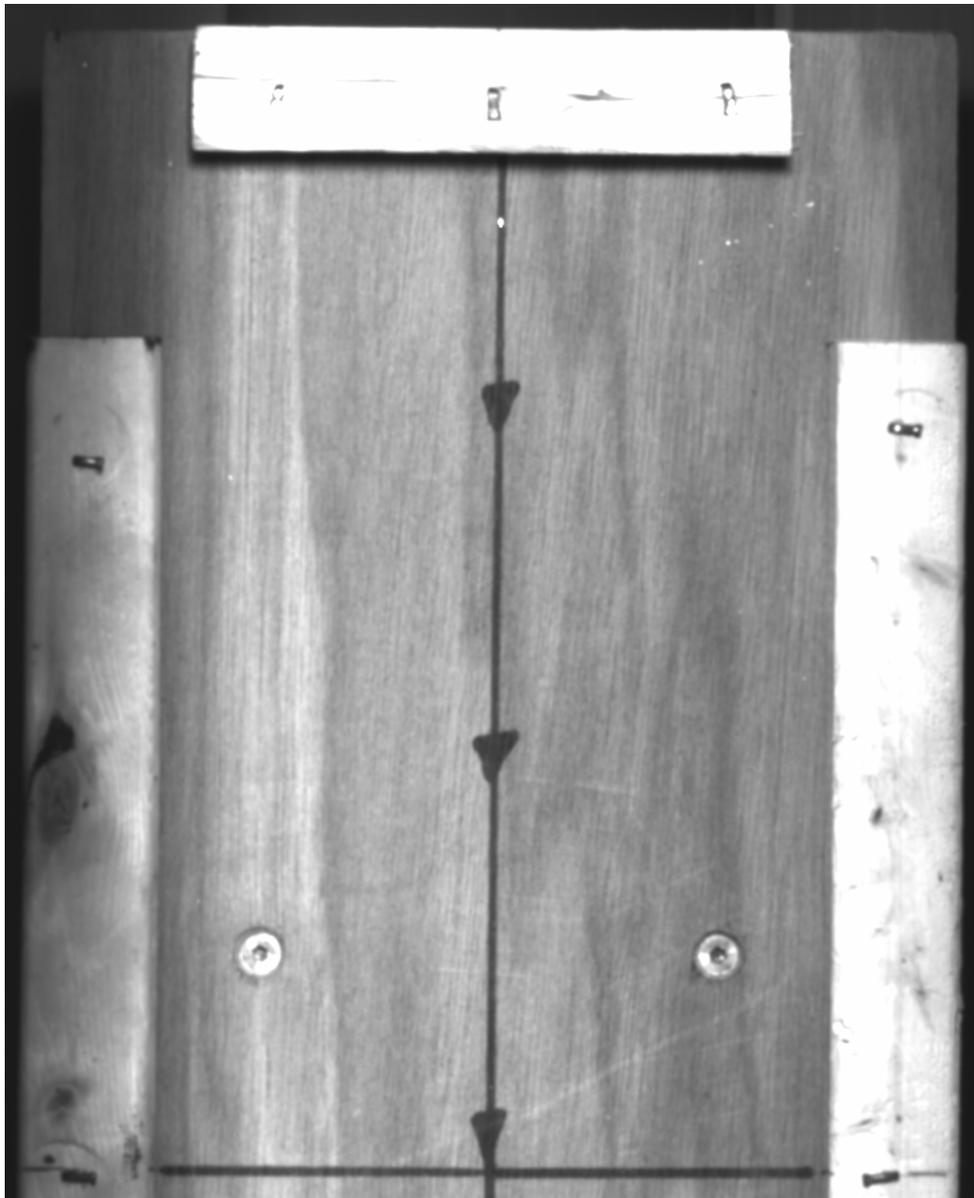
In order to check that the Vision Test System was functioning correctly the test platform was illuminated using two conventional reflector type 100W white lights. The wooden test platform was scanned using the TDI Camera. The platform was moved at an approximate speed of 20in/sec (508mm/sec). The resultant image is shown below. It should be remembered, when considering the quality of the image that we are somewhat limited by the printer and the printing. It is suggested that the electronic version of this document is examined.

You can see that the TDI Camera is clearly picking up the grain structure of the wooden platform. Also the heads of the counter sunk socket head screws can be seen. The horizontal and vertical line was drawn on as a reference and was approximately 0.079" (2mm) wide.
